PARKS AND RECREATION COMMISSION AGENDA REPORT

SUBJECT: REVIEW OF TALBERT REGIONAL PARK FINAL HABITAT RESTORATION PLAN

Figure 1: Talbert Regional Park Project Site

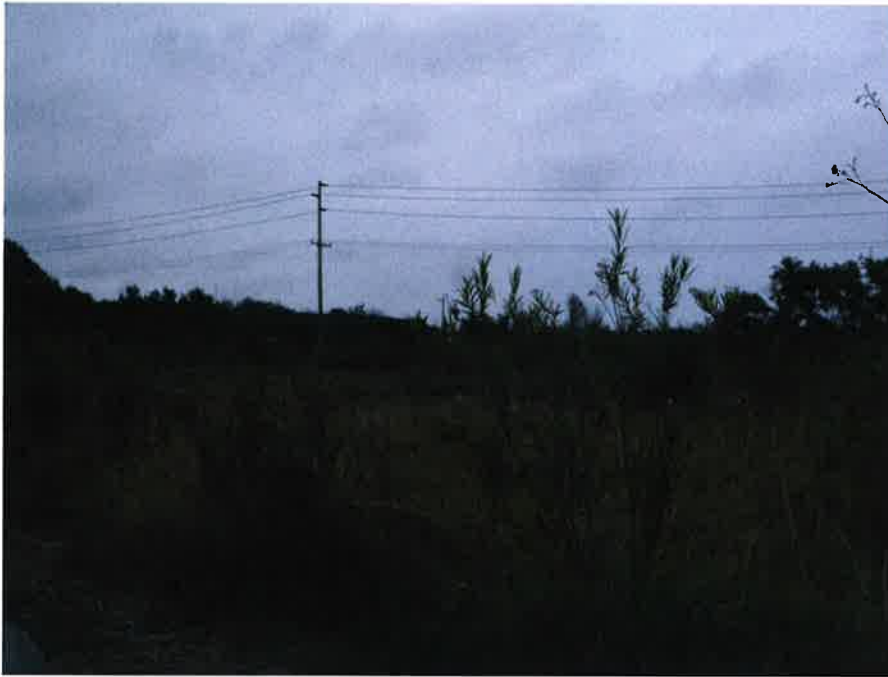
Photo 11. Photo shows a representation of Alkali Sacaton Grassland vegetation found in the southern portion of the Project site. Photo facing south. Corresponds to Photo Point 8.

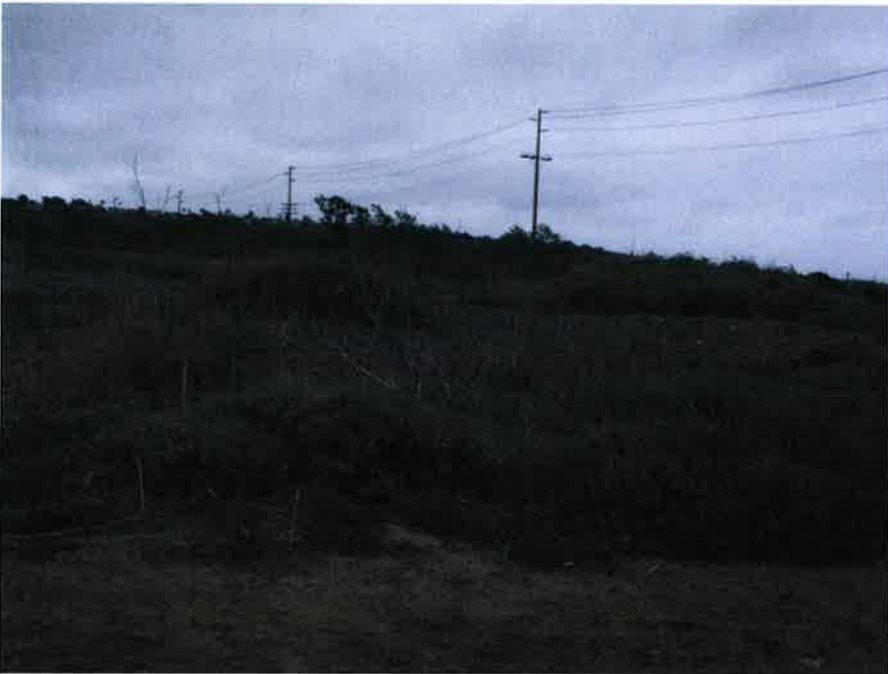
Photo 12. Photo shows a representation of Alkali Heath Marsh vegetation along the western boundary of the Project site. Photo facing southeast. Corresponds to Photo Point 9.

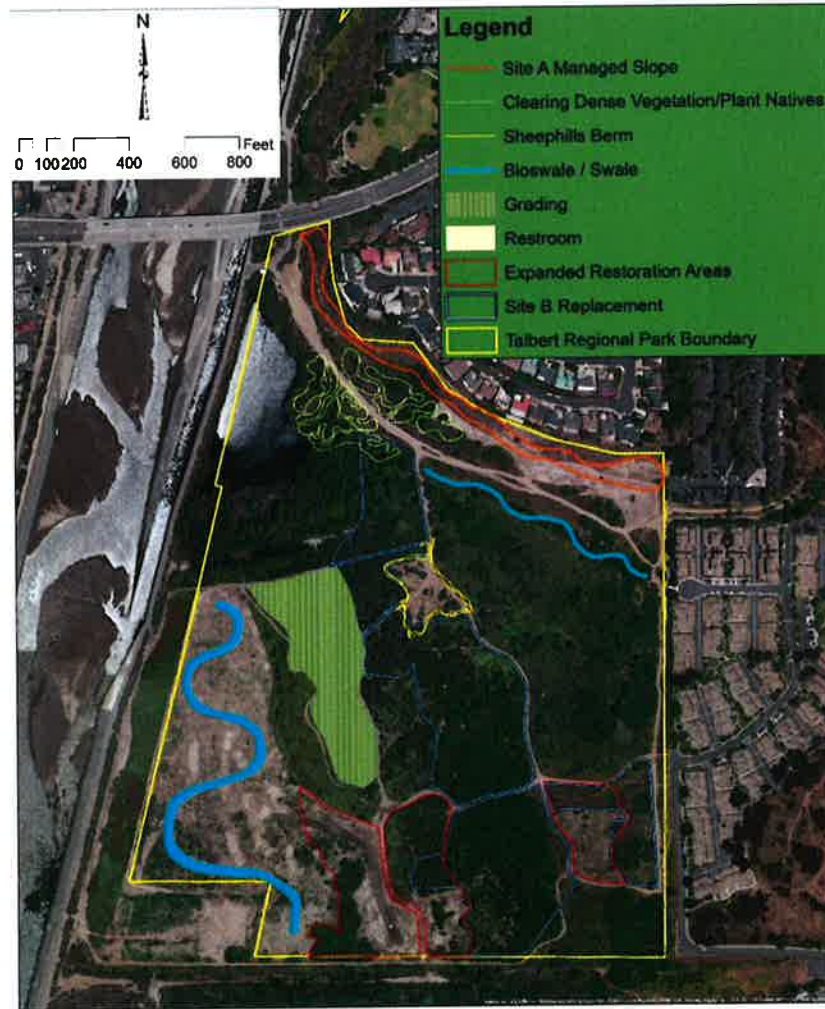
Figure 25: Alternative 2

- Expand the acreage and tree canopy cover in restoration sites C, D and E
- Non-native removal and plantings of riparian habitat
 - Placentia Drain at North Talbert
 - Throughout the site at South Talbert
- Grading the transitional slope for salt marsh wetlands
- Add an ADA compliant loop trail
- Remove the fence around the pond or reconfigure it to allow greater access
- Pier (option) over Victoria Pond
- Stock the pond with fish
- Sheephills will have perimeter grading only for pedestrian traffic

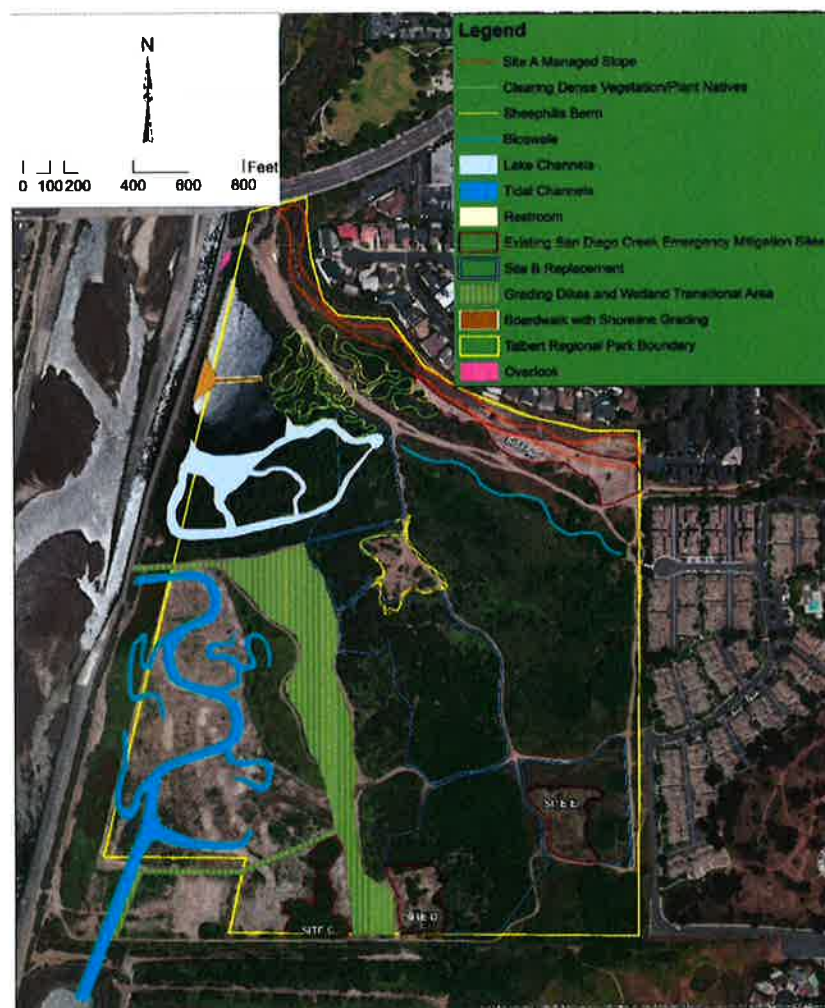
Figure 27: Alternative 3

- Grade existing channel depression in southwest area, add new feeder channels
- Grade drainage channel east of pond and naturalize it
- Non-native removal and plantings of riparian habitat
 - Placentia Drain at North Talbert
 - Throughout the site at South Talbert
- ADA compliant trails
- Boardwalk over Victoria Pond
- Small footbridges over peripheral waterways connecting to Victoria Pond
- Sheephills perimeter grading only for pedestrian traffic
